# COBURN HALL

5D003

# BASE FLOOR PLAN

## HOLMES HALL

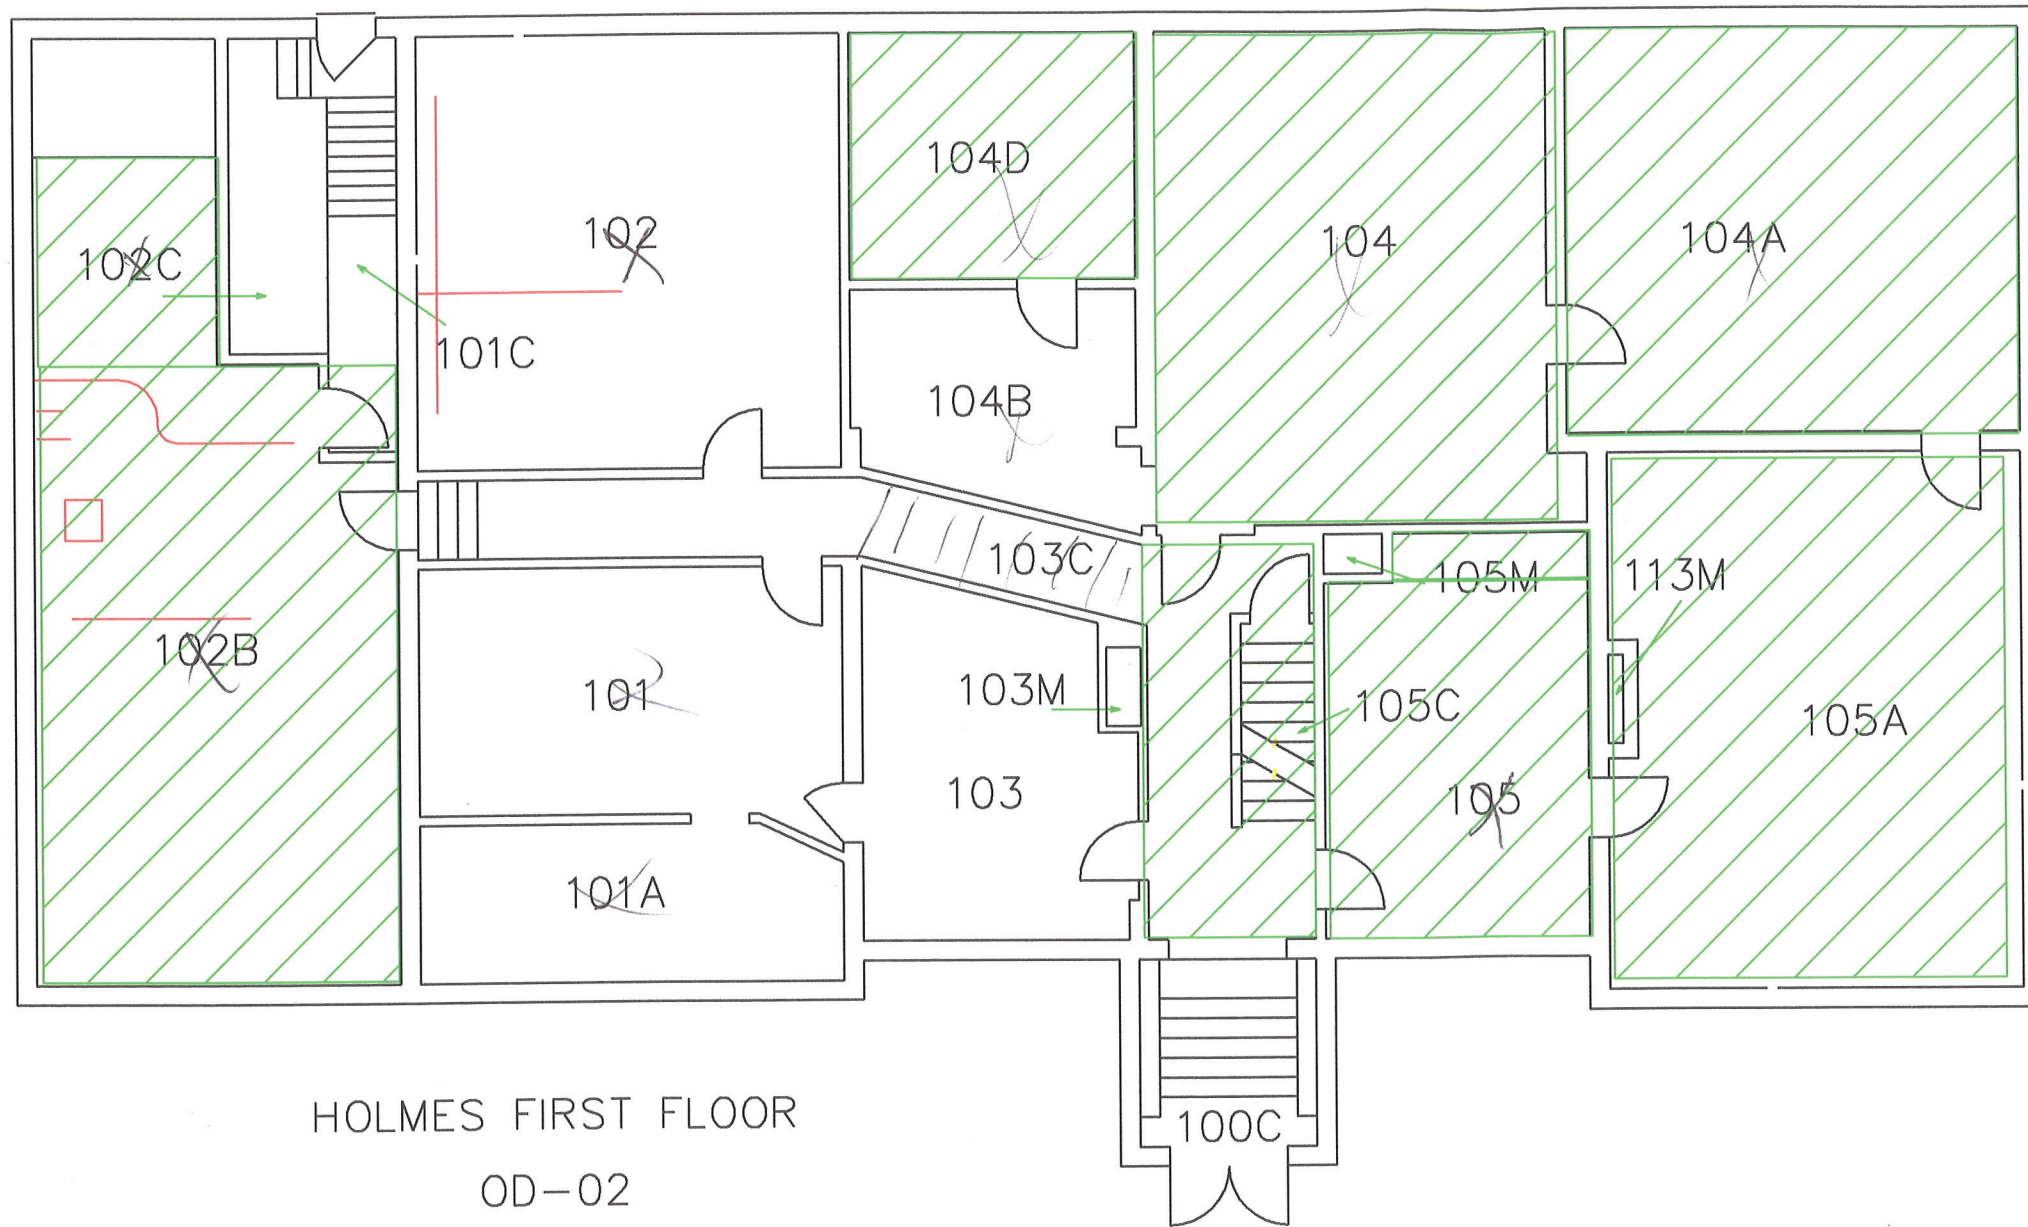
HOLMES FIRST FLOOR  
OD-02

Floor Tile ACM

Ceiling Materials ACM

TSI ACM
Drawing not to scale	
April 2003	
ESP	
Environmental Safety Professionals

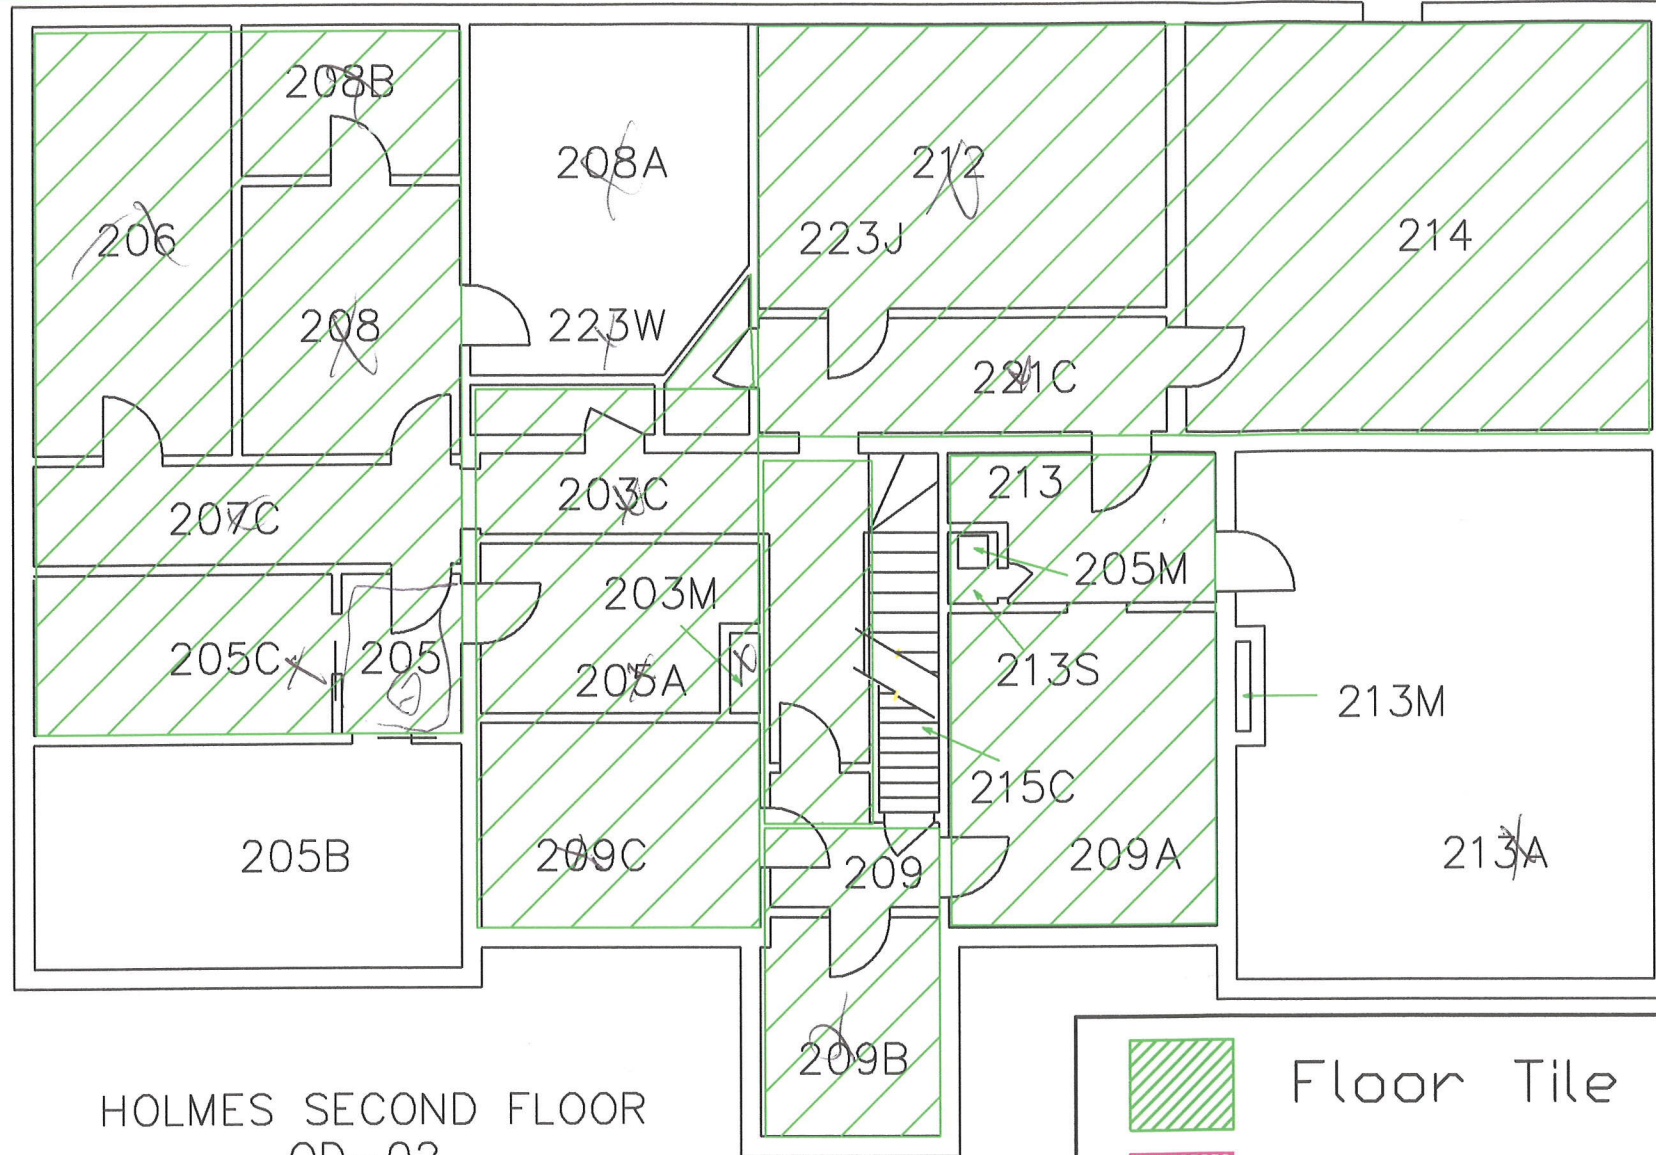
HOLMES SECOND FLOOR  
OD-02

Floor Tile ACM

Ceiling Materials ACM

TSI ACM
Drawing not to scale	
April 2003	
ESP	
Environmental Safety Professionals

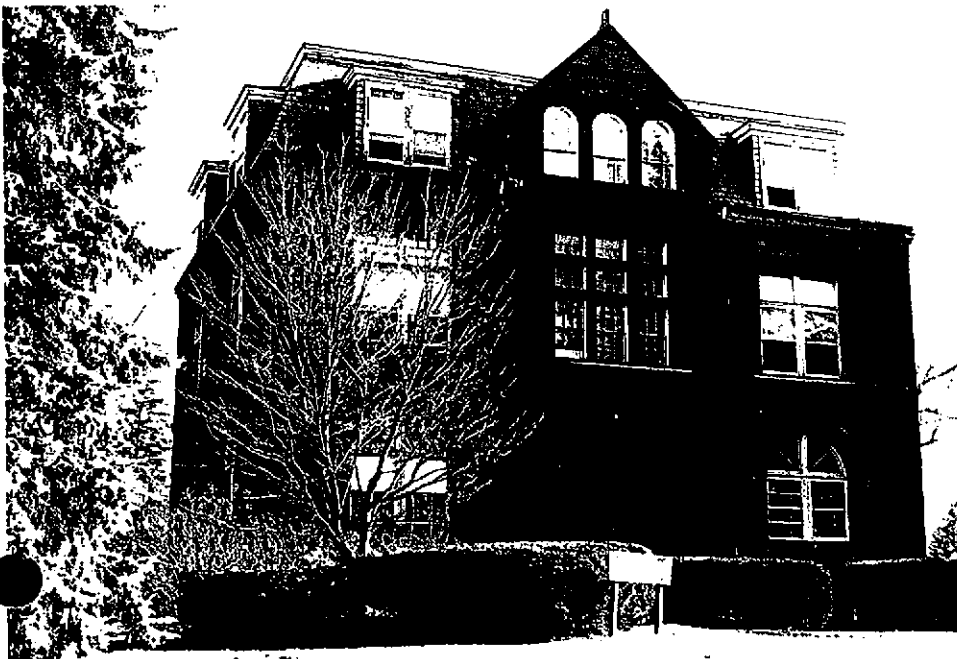
**PHOTOGRAPH**

1. PROPERTY NAME (HISTORIC):	COBURN HALL		
2. PROPERTY NAME (OTHER):	COBURN HALL		
3. STREET ADDRESS:	OD 03		
4. TOWN:	ORONO	5. COUNTY:	PENOBSCOT
6. DATE RECORDED	1/8/02	7. SURVEYOR:	SARA K. MARTIN
8. OWNER NAME:	UNIVERSITY OF MAINE	ADDRESS:	ORONO, ME
9. PRIMARY USE (PRESENT):	EDUCATION		
10. CONDITION:	FAIR

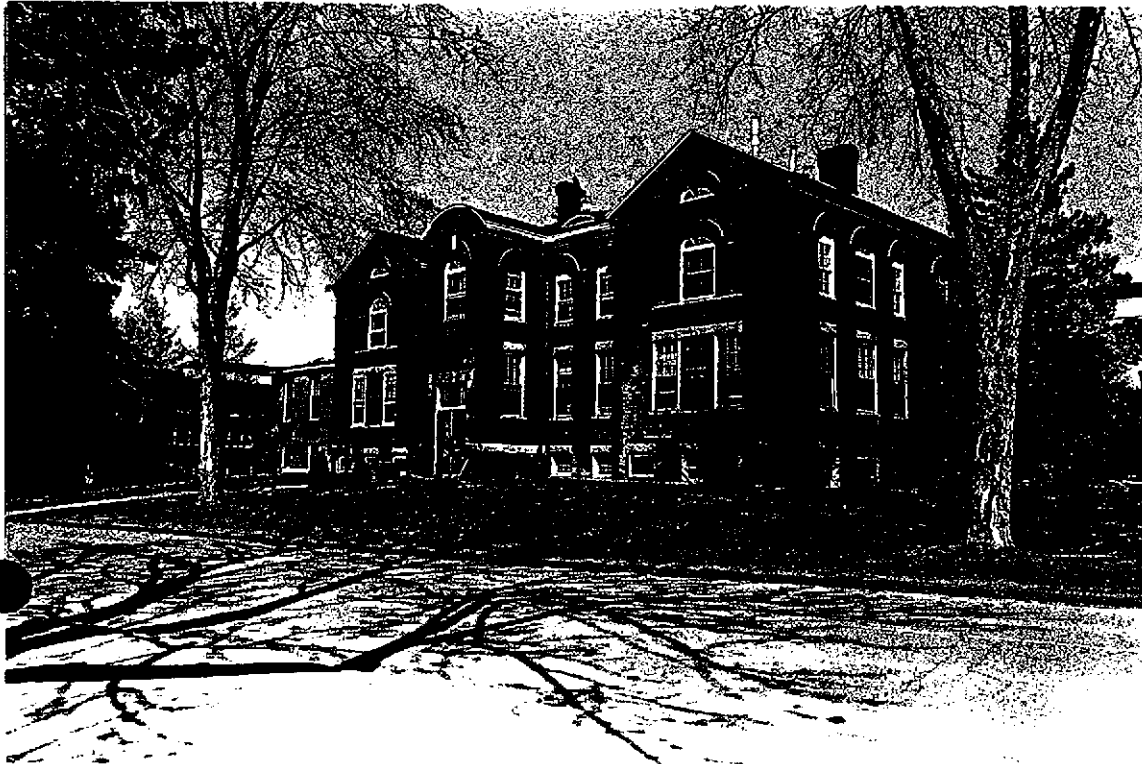
### PHOTOGRAPH

1. PROPERTY NAME (HISTORIC):	HOLMES HALL		
2. PROPERTY NAME (OTHER):	HOLMES HALL		
3. STREET ADDRESS:	OD 02		
4. TOWN:	ORONO	5. COUNTY:	PENOBSCOT
6. DATE RECORDED	5/10/02	7. SURVEYOR:	SARA K. MARTIN
8. OWNER NAME:	UNIVERSITY OF MAINE	ADDRESS:	ORONO, MAINE
9. PRIMARY USE (PRESENT):	EDUCATION		
10. CONDITION:	GOOD
